# Fracture of Polymer Coated Nitinol during Gamma Sterilization

*Dennis. W. Norwich, P.E.*  
*Memry Corporation, Bethel, Connecticut, USA*

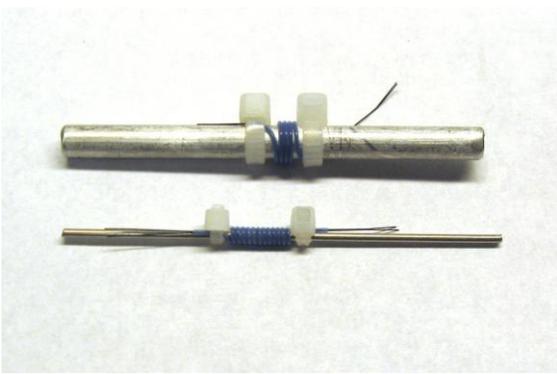
Figure 1: Strained Sample Preparation.

The samples for this research project were prepared to mimic the original occurrence of failure. The wires were encased in the various tubings. The correct strain levels were achieved by winding the samples tightly around appropriately sized mandrels and securing the wire ends (see Figure 1).

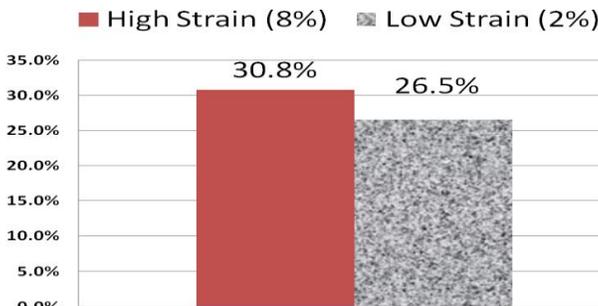
Figure 2: Fractures by Strain Level,  $\phi 0.008''$  Wire, Single Wire Only, All Oxide Levels.

**Strain:** High (8%) strain gave only a slightly higher fracture rate than the low (2%) strain (see Figure 2).

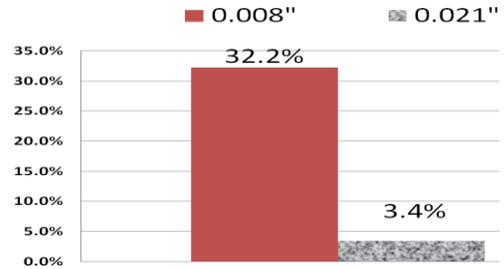
Figure 3: Fractures by Wire Diameter, High and Low Strain, Single Wire Only, All Oxide Levels.

**Wire Diameter:** The smaller ( $\phi 0.008''$ ) wire diameter gave a much higher rate of fracture than the larger ( $\phi 0.021''$ ) wire diameter (see Figure 3).

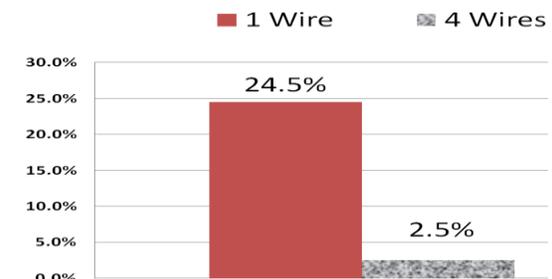
Figure 4: Fractures by Number of Wires, High and Low Strain,  $\phi 0.008''$  Wire, All Oxide Levels.

**Number of Wires:** Single wire samples gave a much higher rate of fracture than multiple wire samples (see figure 4).

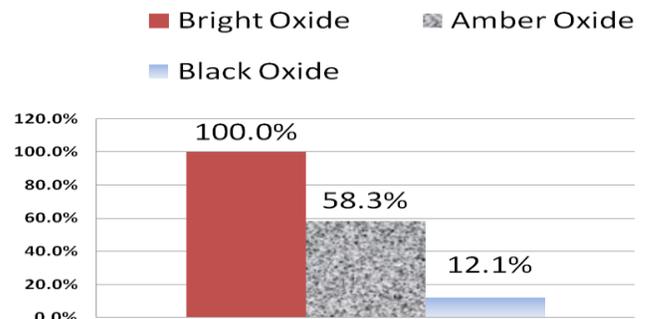
Figure 5: Fractures by Oxide Level, High and Low Strain, Single Wire Only,  $\phi 0.008''$  Wire.

**Wire Surface Finish:** Bright finish (the thinnest oxide layer) gave the highest rate of fracture (see Figure 5).

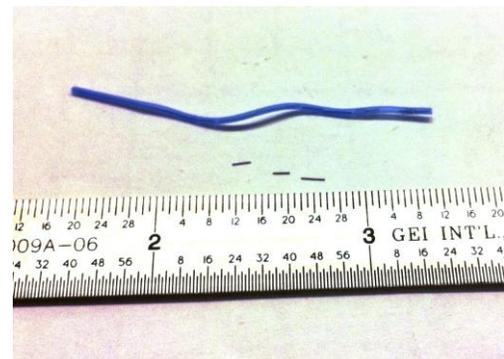
Figure 6: Post Gamma Fracture.

Figure 6 depicts an FEP, high strain,  $\phi 0.008''$  wire, single wire, bright oxide sample. Note that the sample fractured into many pieces each approximately 3mm in length. This combination of variables led to the highest rate of fracture for the Nitinol wire.

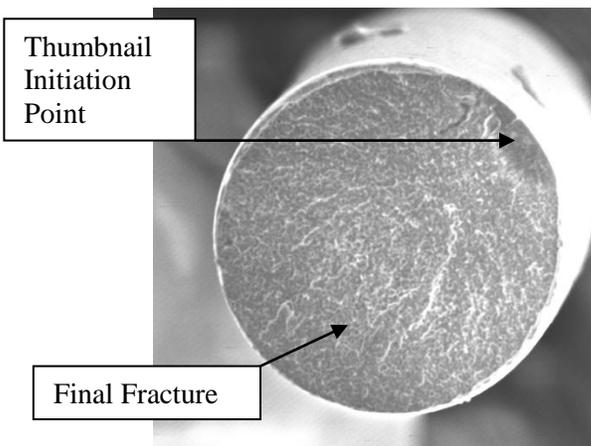
Figure 7: SEM Image of Post Gamma SCC.

Scanning Electron Microscope (SEM) analysis was used to analyze the surface of samples that were fractured during gamma exposure. See Figure 7 below. The image at first appears to be a fatigue-like fracture morphology [3]. This is obviously not the case as the sample was fixed to the mandrel at all times.

This actually is a perfect example of Stress Corrosion Cracking (SCC). SCC is a phenomenon most famously described by the British Army in the 1800s in India. The thin-walled necks of their cartridge cases cracked spontaneously during the monsoon season. The source of the problem was traced to a combination of high temperature and humidity, and traces of ammonia in the air [4].

The Nitinol fractures reported here show a small discolored thumbnail initiation point with fatigue like striations of propagation. The propagation is a result of a corrosive attack of the wire while under stress. The Corrosion Tunnel Model proposes that the crack propagates through a series of steps of alternating tunnel growth and ductile fracture [5]. The final fracture by overload is microvoid coalescence caused by stress concentration [3,4].

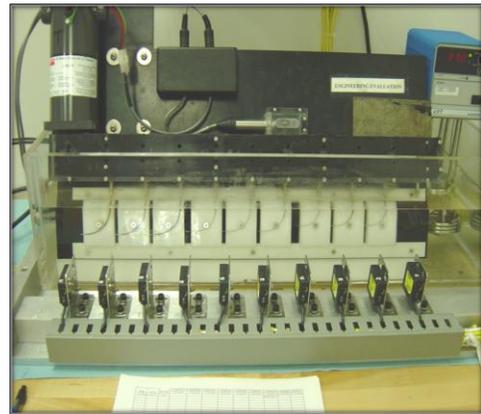
Figure 8: Rotating Beam Test Apparatus.

Fatigue testing was performed on the straight wire samples using a rotating beam fatigue tester (RBT). This is a zero mean strain test device. It can test up to 10 samples at a time with the wire guided in a test block machined with a radius to provide the desired strain level. Cycles to failure are recorded by a laser counter. The tests were performed in a 37°C water bath at 1000 RPM. The water bath eliminates any heating effect created in the specimen due to dissipative processes during cyclic loading (cyclic stress induced formation of martensite). The heat transfer from the specimen to the test environment helps to counteract this process [6]. The RBT test apparatus is shown in Figure 8.

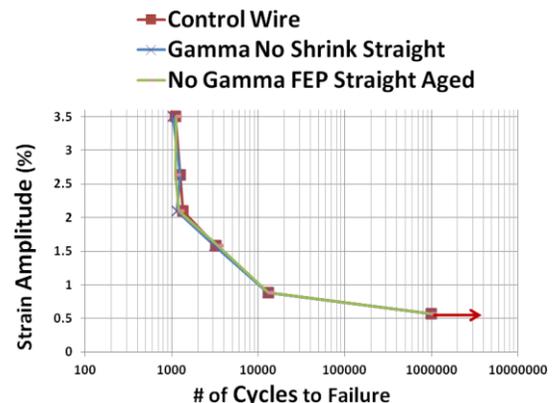
Figure 9: Strain-N NiTi Control Samples.

Fatigue life ( $\epsilon$ -N) curves were generated for wire samples subjected to various combinations of FEP tubing, gamma irradiation, and strain. In Figure 9, the three samples consist of a control wire that was not exposed to FEP tubing or gamma irradiation, a wire that was gamma irradiated without FEP tubing, and a wire that was encased in FEP tubing and aged for four months without gamma irradiation. You can see that the three curves lie on top of each other and all samples ran out at one million cycles at 0.6% strain; therefore the FEP tubing or the gamma irradiation individually do not affect the fatigue life of the Nitinol wire.

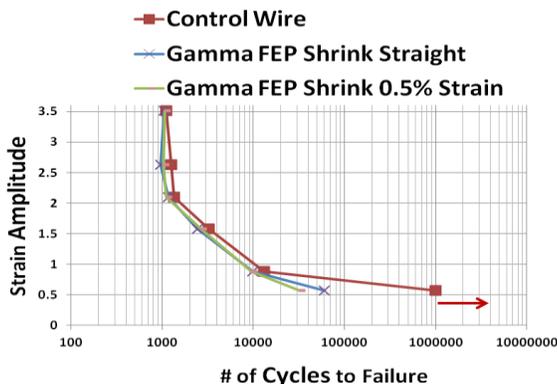
Figure 10: Strain-N NiTi Irradiated with FEP.

In Figure 10, we again see the same control wire that was not exposed to FEP or gamma irradiation. It is plotted against wires with FEP that were gamma irradiated in a straight condition and wires with FEP that were gamma irradiated while being held at 0.5% strain.

The results show the latency of the exposure to irradiated FEP. Even without fracture, there is a drastic reduction of fatigue life caused by the irradiated FEP. The average fatigue failure at 0.6% strain dropped from run out at one million cycles to failure at 60,000 cycles. This is exacerbated by holding the wires under 0.5% strain during irradiation where the fatigue failure at 0.6% strain dropped to 32,000 cycles.

Any application containing Nitinol along with a halogenated polymer should be thoroughly reviewed and tested before specifying any irradiated sterilization method.
